Deja View and Power Wagon Trails Environmental Screening Report

Date: October 27, 2014

Prepared by: Jeremy Ayotte MSc, RPBio

Prepared for: Columbia Valley Greenway and Trails Alliance

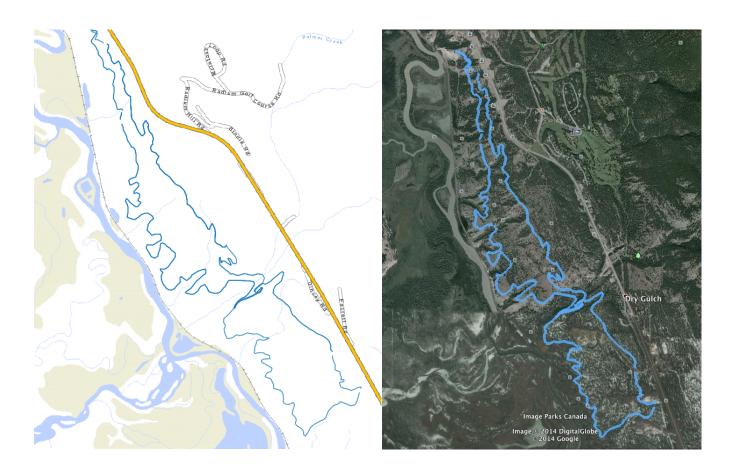
Figure 1.Overview map showing the location of the Deja View and Power Wagon trail network (blue). Right side overlays satellite imagery.

These well-used trails are located east of the Columbia River and west of Highway 93/95, linking the communities of Dry Gulch and Radium (Fig.1). Based on a survey conducted by the CVGTA, the Deja View trail is the most popular trail in the valley. These are very accessible trails that are used primarily by dog-walkers, trail runners, hikers and mountain bikers. Recreational use of the trail network is year-round depending on winter weather, but the majority of use is between March and November.

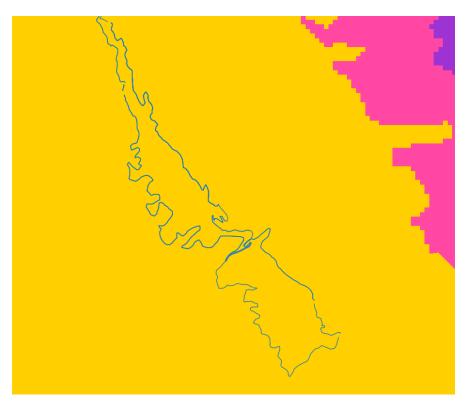
Figure 2. Map showing that the trail system is completely within the IDFxk biogeoclimatic zone (yellow).

Deja View and Powerwagon trails are within the IDFxk biogeoclimatic zone. The IDFxk (dry, cool Interior Douglas-fir), (Fig. 2, and see Plant Community report for full details). Based on a search of the BC Conservation Data Centre's database, there are two Blue listed ecological communities that can occur within the IDFxk biogeoclimatic zone in the Kootenay Region: Hard-stemmed bulrush Deep Marsh, and Common Cattail Marsh. Neither of these ecological plant communities are within the impact zone of the trail network.

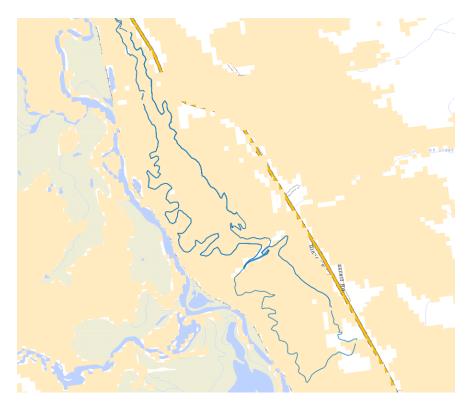
Figure 3.Map showing the trail system almost completely within provincially managed Ungulate Winter Range (UWR U-4-008) in beige.

A spatial search of provincial wildlife data found that the almost the entire trail network is within provincially managed Ungulate Winter Range (UWR U-4-008). These areas contain habitat that is necessary to meet the winter habitat requirements of an ungulate species. UWR U-4-008 was approved to protect winter range habitat for White-tailed deer, Mule deer, moose, elk, bighorn sheep, and mountain goat.

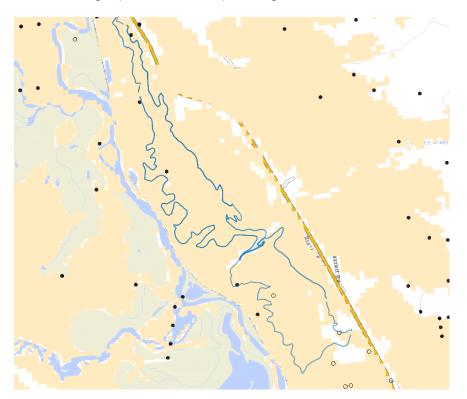
Figure 4.Map showing point locations of wildlife from the provincial wildlife inventory database (SPI). Solid points are visual observations, outlined points are telemetry (from animals fitted with radio collars). Ungulate Winter Range (UWR U-4-008) is also shown in beige.

Another spatial search overlayed the provincial wildlife inventory database (SPI) on the trail network revealing previous studies that recorded locations of Bighorn sheep (6 points), badger (4 points, 2 from radio collared animals), and White-tailed deer (2 points) in the project area (Fig 4).
